Home Inspection Report

31 Becker Street
Lake Peekskill, NY 10537

Inspected By: Derek Nagel
Inspected On Sat, Mar 16, 2024 at 9:31 AM

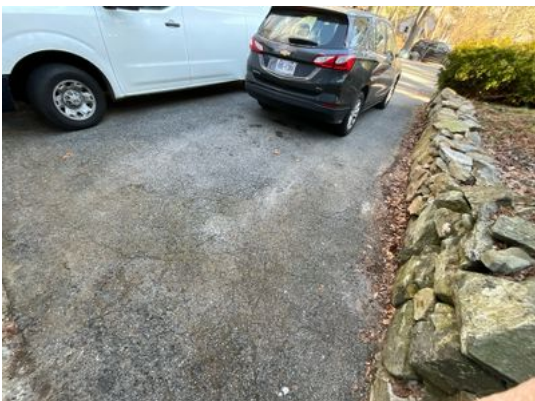
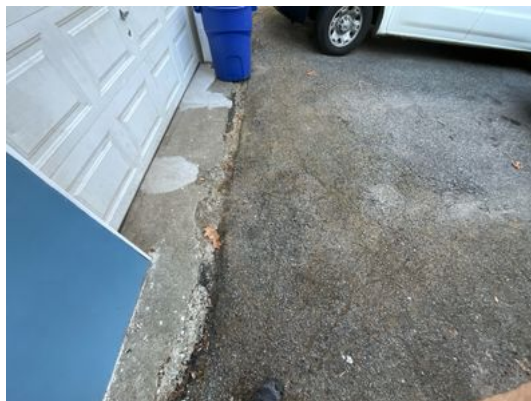
Condition: Marginal

Driveway in marginal condition, recommend having a asphalt contractor, assess, and seal

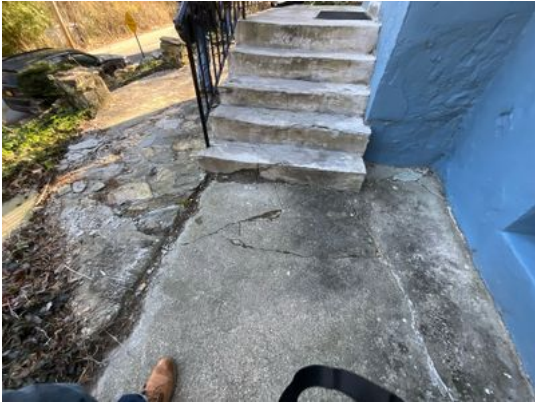
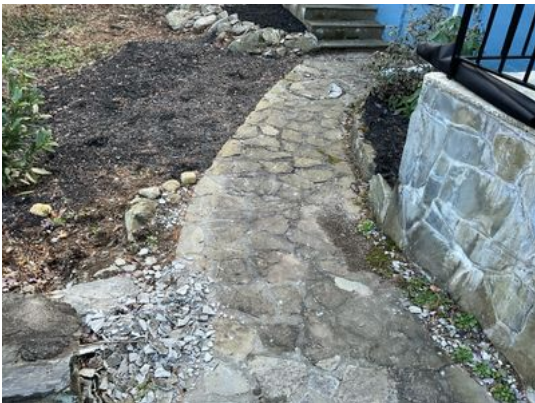
Walkways

Condition: Marginal

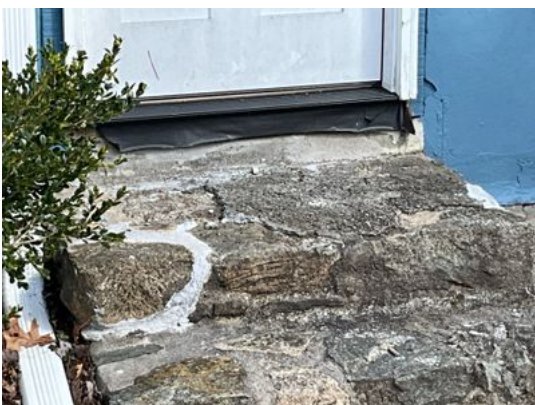
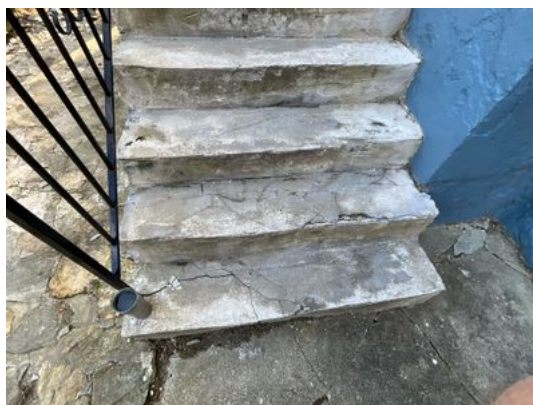
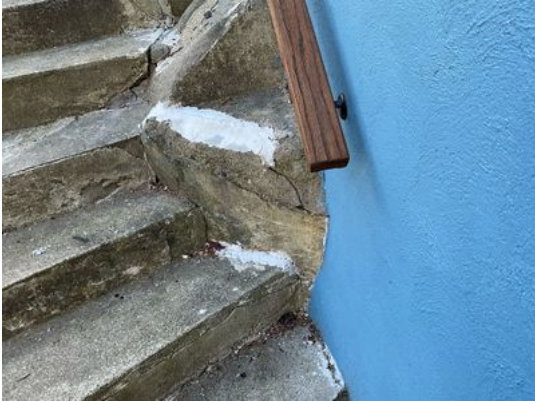
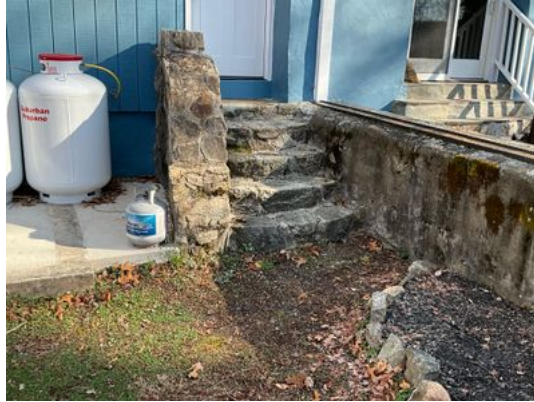
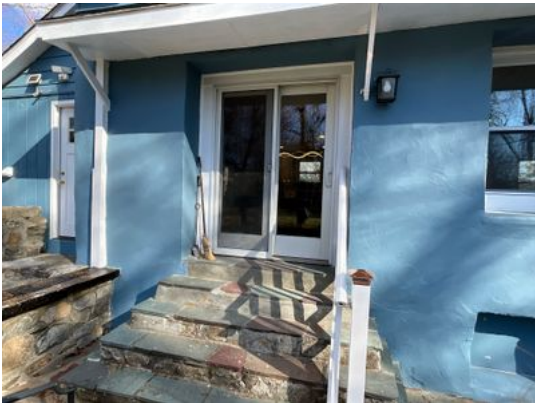
Steps/Stoops

Condition: Marginal

All stairways around exterior of house are stone/masonry. Several stairways have mortar flaking and/or concrete cracking. Recommend having stairways evaluated by a qualified masonry contractor.

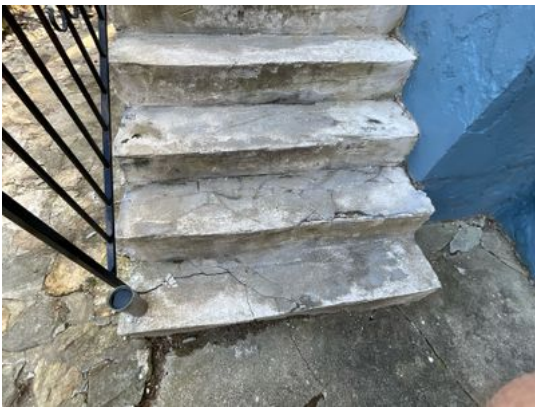
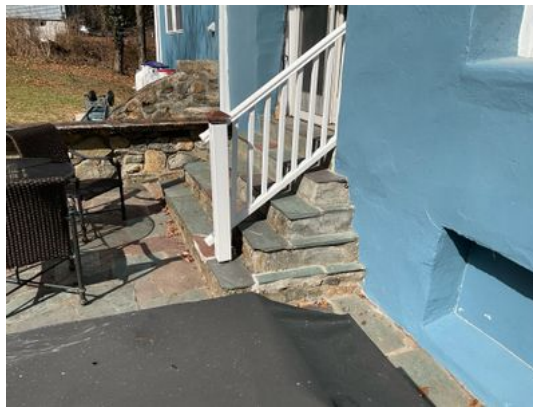
Railings

Handrail on front steps has open ends which poses a “snag” risk and therefore is a safety concern. Recommend hiring qualified contractor to install a handrail with ends that are returned to the wall
