Home Inspection Report

31 Becker Street
Lake Peekskill, NY 10537

Inspected By: Derek Nagel
Inspected On Sat, Mar 16, 2024 at 9:31 AM

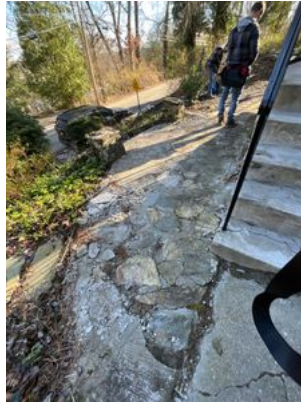
Condition: Marginal

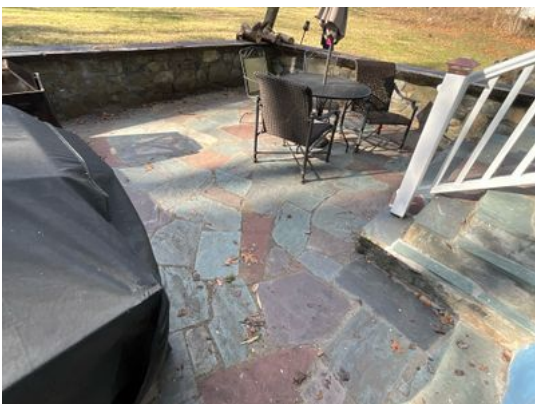
Condition: Marginal

All stairways around exterior of house are stone/masonry. Several stairways have mortar flaking and/or concrete cracking. Recommend having stairways evaluated by a qualified masonry contractor.

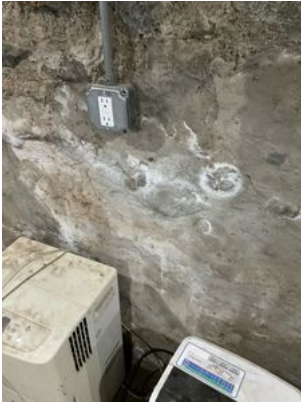
Signs of Water Penetration

Efflorescence

Condition: Further Evaluation Required

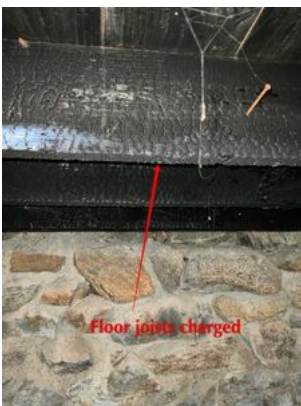
Condition: Further Evaluation Required

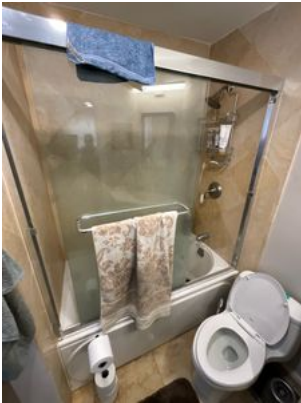
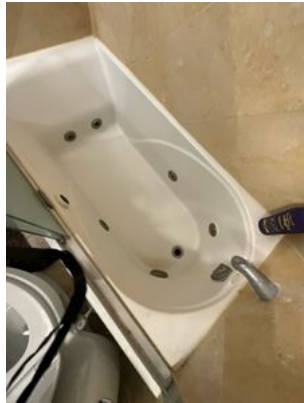
Recirculating

Condition: Satisfactory

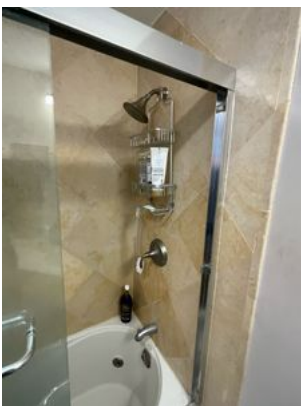
Shower

In Tub

Condition: Satisfactory

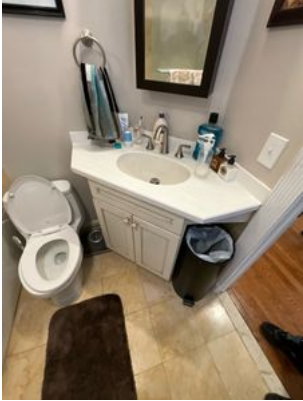
Sink(s)

Single Vanity

Condition: Satisfactory

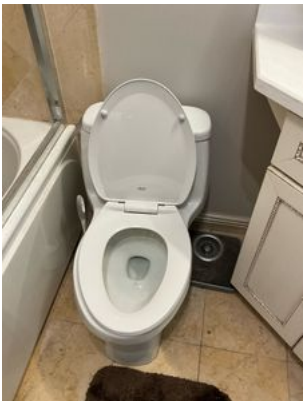
Toilet

Standard Tank

Condition: Satisfactory

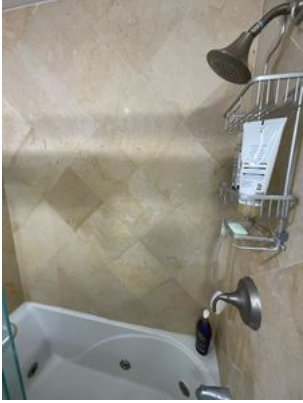
Marble

Condition: Satisfactory

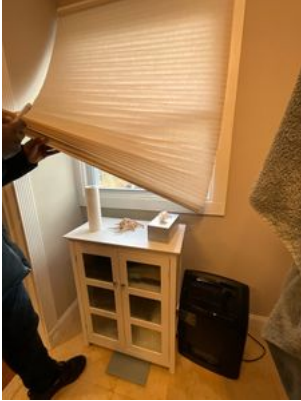
Ventilation Type

Window

Condition: Satisfactory

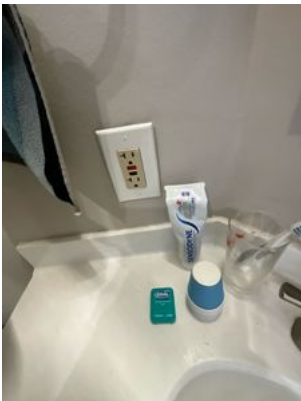
GFCI Protection

Outlets, Recirculating Tub

Condition: Satisfactory

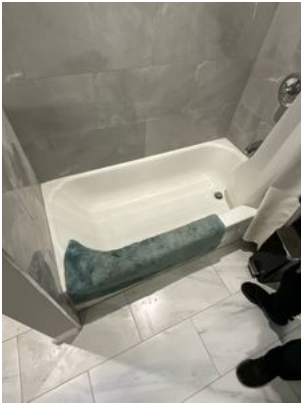
Bath Tub

Recessed

Condition: Satisfactory

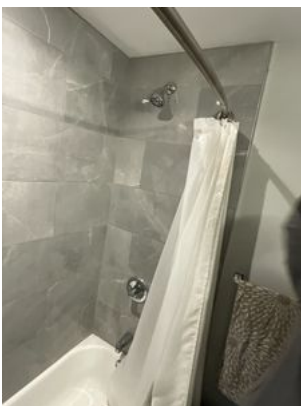
Shower

In Tub

Condition: Satisfactory

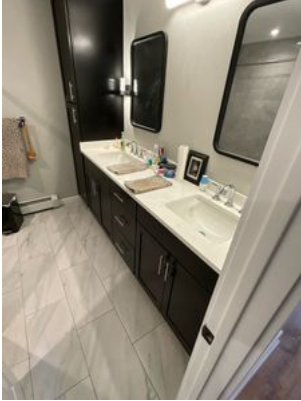
Sink(s)

Double Vanity

Condition: Satisfactory

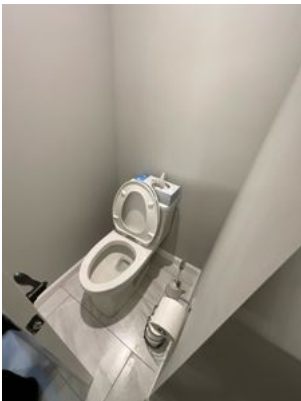
Toilet

Standard Tank

Condition: Satisfactory

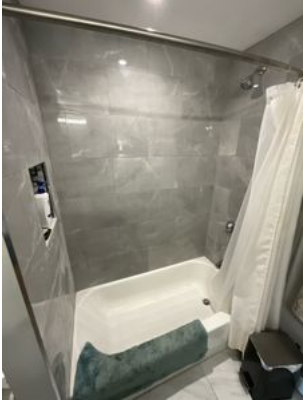
Tile

Condition: Satisfactory

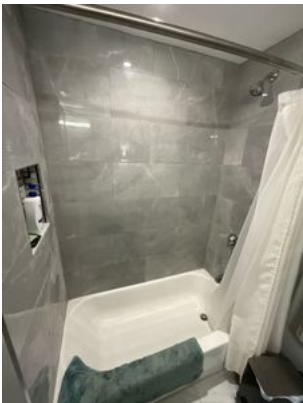
Tub Surround

Tile

Condition: Satisfactory

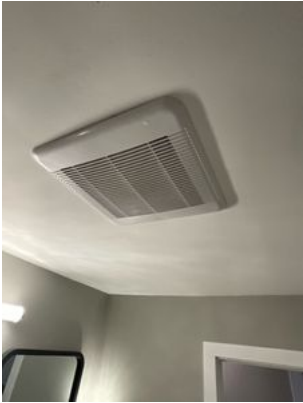
Ventilation Type

Ventilator

Condition: Satisfactory

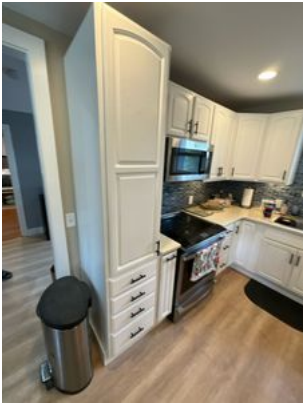
Cabinets

Wood

Condition: Satisfactory

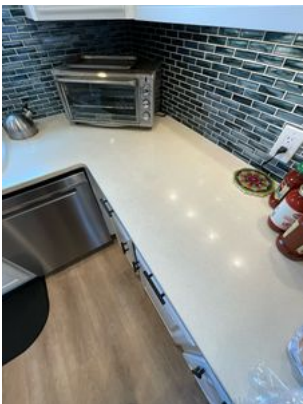
Countertops

Quartz

Condition: Satisfactory

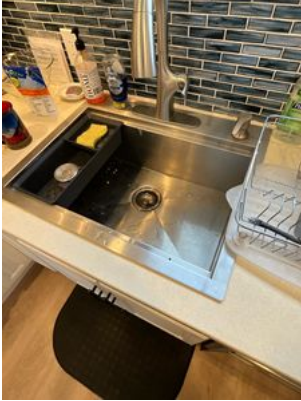
Sink

Single

Condition: Satisfactory

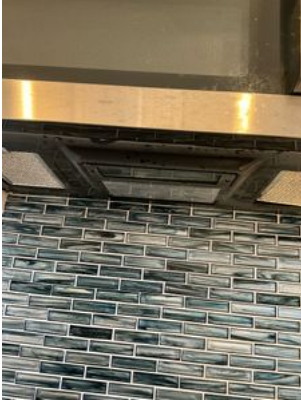
Condition: Satisfactory

Vent located in microwave. It operated at the time of inspection. The hood recirculates the air and is not vented to the outside. While this is fine, I recommend replacing filters on a routine basis.

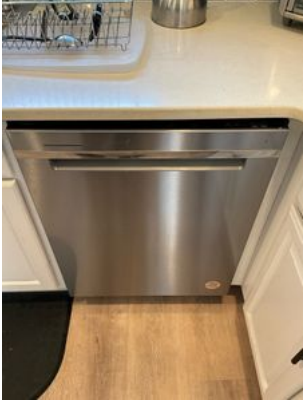
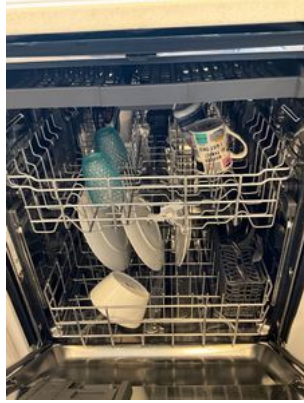
Dishwasher

Whirlpool

Condition: Satisfactory

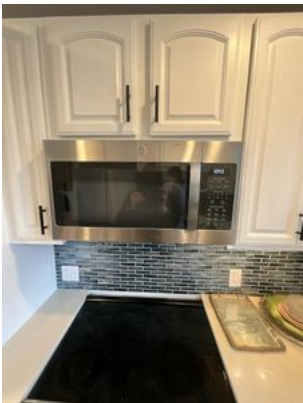
Microwave

General Electric

Condition: Satisfactory

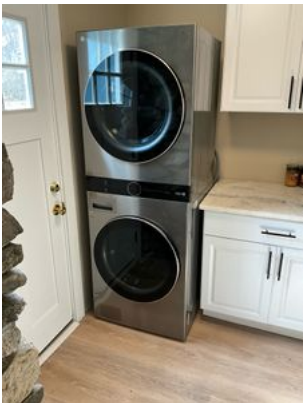
Dryer

LG

Condition: Satisfactory

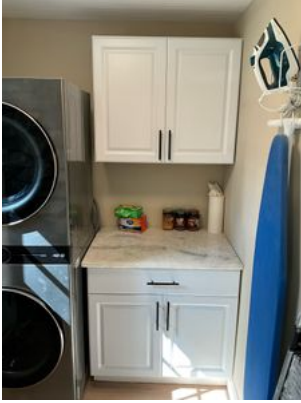
Built In Cabinets

Yes

Condition: Satisfactory

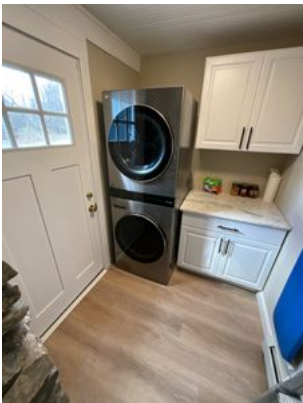
Washer

LG

Condition: Satisfactory

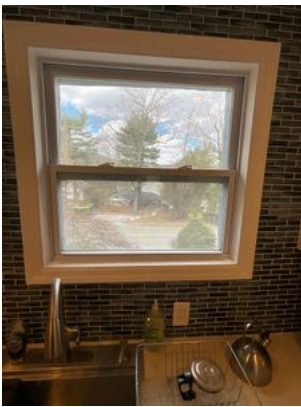
Double Hung

Condition: Satisfactory

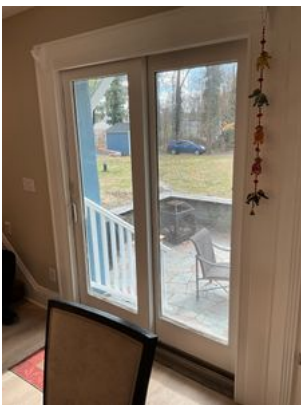
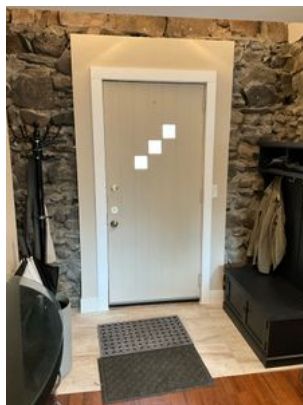
Sliding, Hinged

Condition: Satisfactory

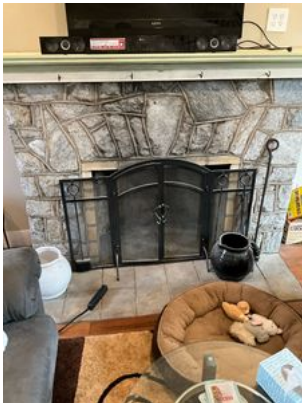
Wood Burning

Condition: Satisfactory

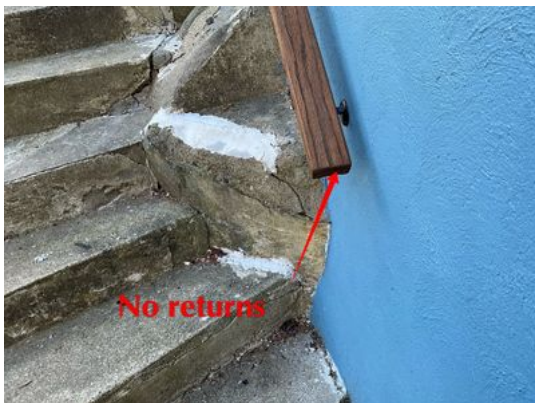
Exterior: Railings

Handrail on front steps has open ends which poses a “snag” risk and therefore is a safety concern. Recommend hiring qualified contractor to install a handrail with ends that are returned to the wall
